# Manhole Inspection Summary

Manhole # S57E\_\_011MH

Insp Date: **6/30/08 10:01 AM**

**Location** Address: **3925 e lombard st**

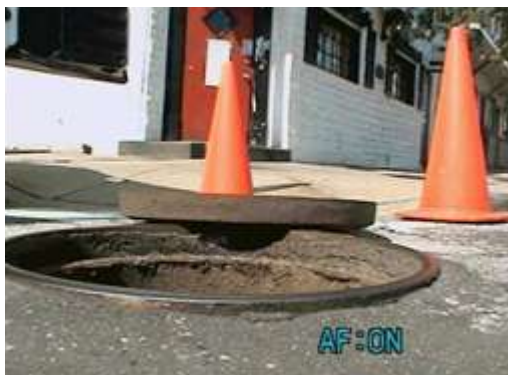
Location View

location view & above grade 1inch

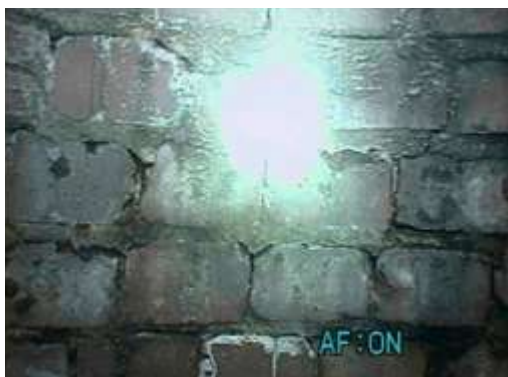
Defect 3

Condition: ☐ Sound ☐ Cracked ☐ Root Intrusion ☒ **Loose Brick** ☐ Deteriorated

missing mortar in barrel

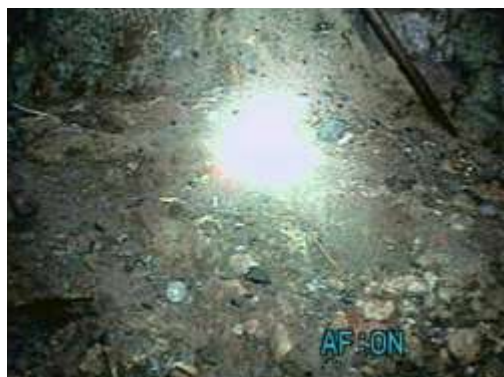
Defect 2

Condition: ☐ Sound ☐ Cracked ☐ Root Intrusion ☐ Deteriorated ☐ Leaks ☒ **Debris**

bench debris

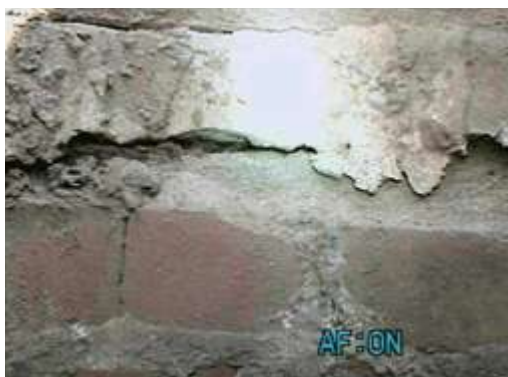
Defect 1

Condition: ☐ Sound ☒ **Cracked** ☐ Root Intrusion ☐ Loose Brick ☐ Deteriorated

chimney cracked, frame adj

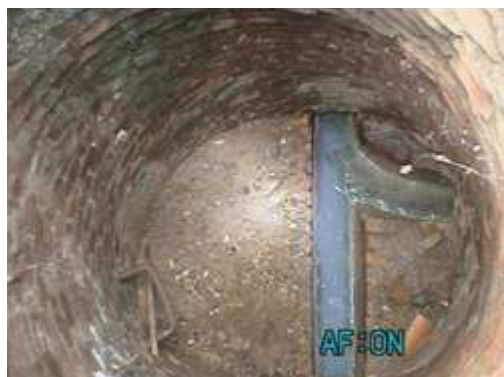
Defect 4

Count: **4** Missing: **2** ☒ **Corroded**

corroded and 2 missing steps
